# TIMBER FRAMING

JOURNAL OF THE TIMBER FRAMERS GUILD

Number 95, March 2010

# The Riddle of Tremblay

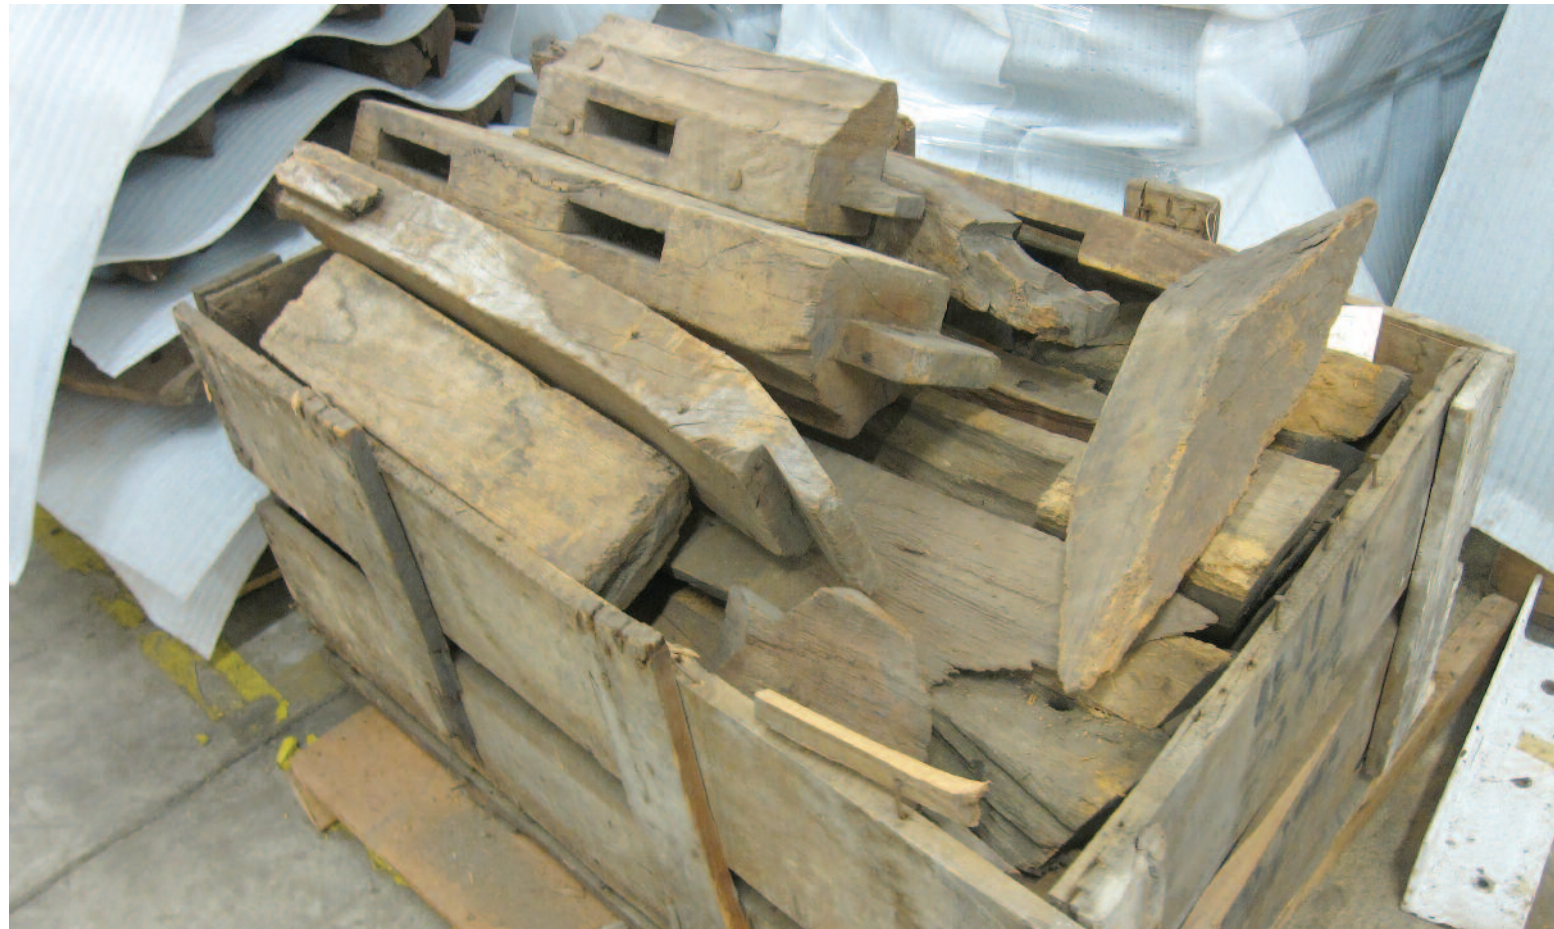
1

IN 2002, the Philadelphia Museum of Art was about to relocate the contents of a storage facility, among them a 6-ft. stack of timbers 5 ft. wide and 60 ft. long, as well as crates of small pieces (1), all supposedly representing a late medieval French refectory ceiling called Tremblay, and acquired by the institution in 1941. With the exception of a few accompanying contemporary letters, records were absent. Dean Walker, Curator of European Art at the Philadelphia Museum, asked us to decipher the timbers.

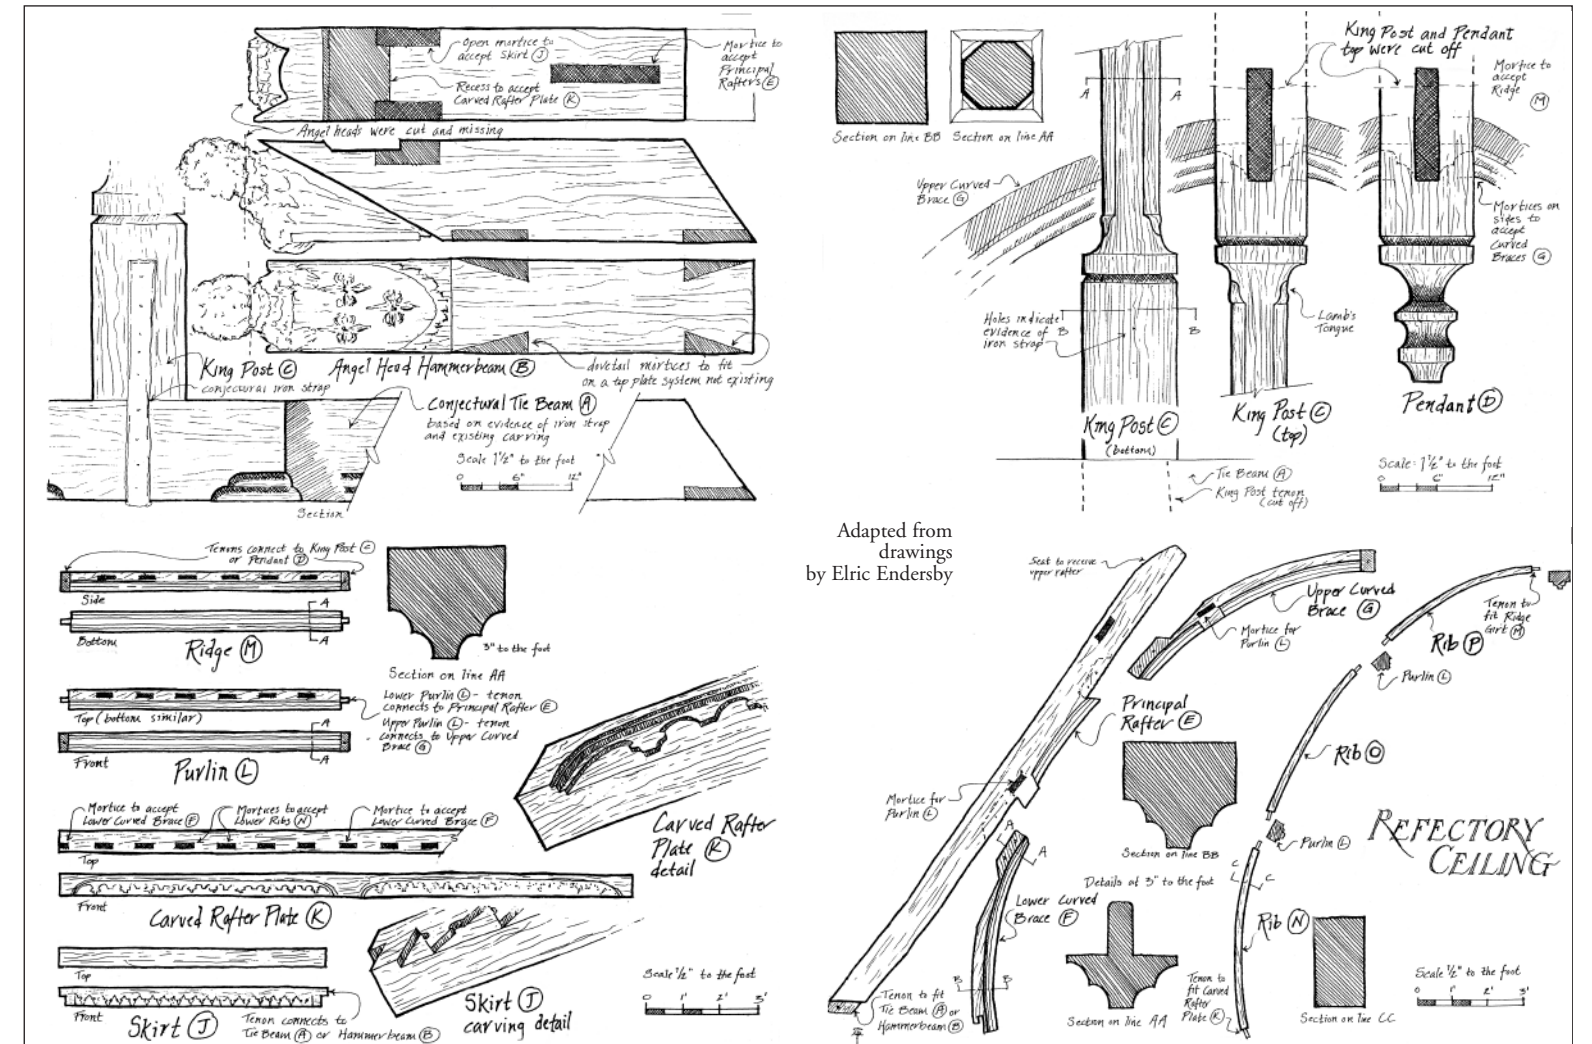
Adapted from drawings by Eric Endersby

The timbers fell into several distinct categories. The most conspicuously decorated were short, carved pieces we came to call hammerbeams (B in the drawings on the facing page), after similar unbraced members in Outwell Church, Norfolk, so called and shown in Raphael and Arthur Brandon's *Open Timber Roofs of the Middle Ages*. Measuring about 4 ft. 6 in. long and 11 in. square, the hammerbeams were embellished at one end with winged angels, all but one of whose faces (3) had been hacked off, possibly during the French Revolution. The angels clutched shields adorned not just with mitres and roses but a number of different heraldic emblems (4 and back cover). At the opposite end, the hammerbeams were angled back bottom to top by 7½ in., suggesting a roof pitch of 7½ by 11. The bottom surface was fashioned with two shallow lap dovetails at each end. The upper surface near the angel carving was relieved to receive a passing timber (K in the drawings), while an 11½-in.-long mortise was chiseled at the other end to accept a major rising timber, likely a principal rafter.

A separate group comprised two sorts of probably related timbers. One, apparently kingposts (C), measured 12 ft. 9 in. long, with central chamfered sections of 9 ft. 6 in. The other sort, apparently pendants (D), were about 2 ft. long and terminated in remarkably various carved square turnings (see cover photo). Both sorts of timbers were about 10 in. square in section and, with one exception, displayed 7-in. open mortises on all four sides. All of these members, short and long alike, appeared to have been cut at or just inside these mortises.

A third set of timbers seemed likely to be horizontal elements. There were four distinct but related types (J, K, L and M), of which J, L and M were approximately 7 ft., 5 in. in length.

Timbers type (K) were 15 ft. 10½ in. long, with major mortises at the center and on each side a series of six evenly spaced mortises on the upper surface. The same evenly spaced mortises occurred on both the upper and lower surfaces of the L and M timbers. The tenons at the ends of the L timbers were oriented vertically; on the M timbers they were horizontal. The remaining horizontal type (J) was more highly decorated, had no mortises and terminated in half-laps at both ends in place of tenons.

A final series of structural members were arched over all or part of their length. The vast majority of these took the form of slender ribs in three slightly different lengths (N, O and P). Of the remaining members (E, F and G), it became evident that together these formed arched bents, the principal support for the ceiling. Although different in length, F and G were fashioned with the same molded profile as on the horizontal members L and M and were acutely angled at one end with long blade-like tenons. In sorting through the entire stack of timbers, we discovered only two examples of a particular beam into which these timbers would fit. That single pair of principal rafters (E) displayed the same molded profile as the curved braces (F and G) but over only 3 ft. of their much greater length. Still, when joined together with the other arched and molded timbers, they formed the two sides of a Gothic arch (5).

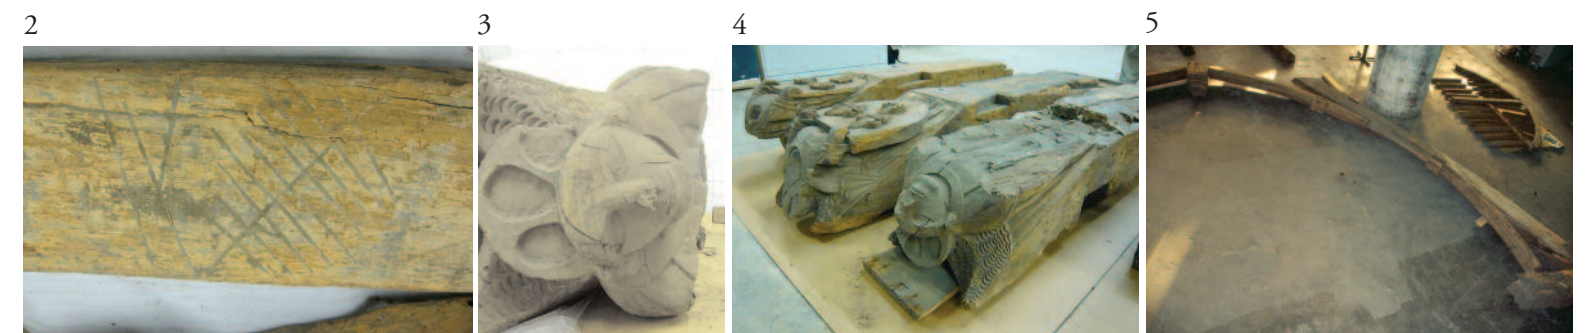
With the pendant in place as the central uppermost member and an angel-head “hammerbeam” neatly fit at the bottom on each side, we were finally able to make a full assembly.

Fitting together these arched timbers was just the beginning of the assembly process. The next step was to find a companion member to receive the tenons at the top of each of these half-arches. Eventually we recognized that the tenons could be fit into either C or D, the former a boss or pendant, the latter a kingpost.

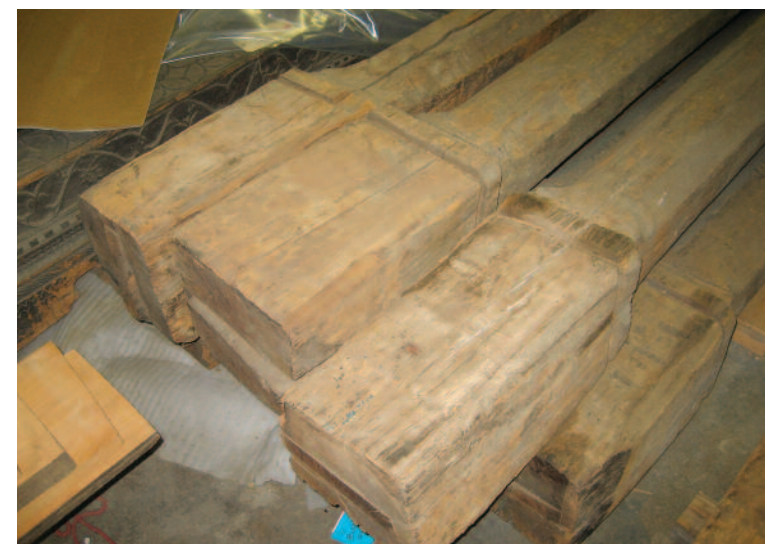
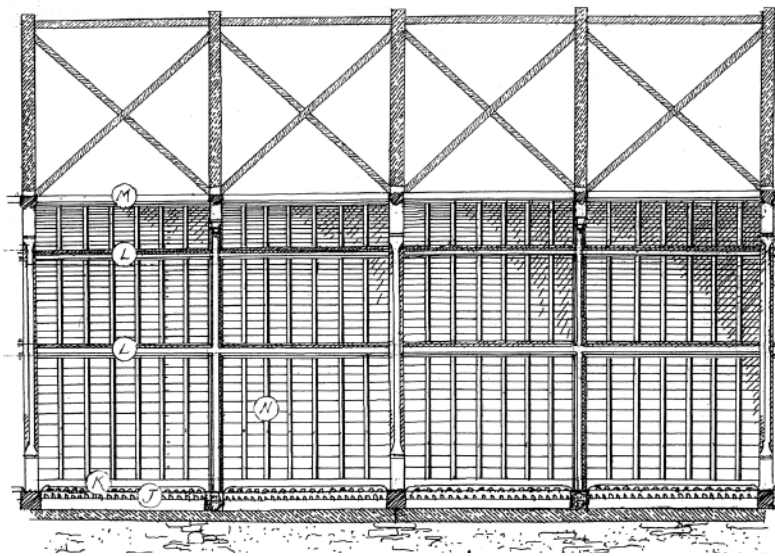
6

The alternative composition, using the kingpost in place of the pendant, was more challenging. The base of each kingpost originally terminated in a central tenon (on the remaining evidence a wedged half-dovetail) cut off during disassembly (6). And we had no tie beams to span the distance between the rafter feet and to join the kingpost at midspan. Despite the mention of “80 cross beams” in the museum inventory of 1941, none of these crucial members, evidently the “crossbeams” mentioned by Barnard, had accompanied the accession.

Judging by the lap dovetails cut into the bottom surface of the so-called hammerbeams, they (along with the missing tie beams) were originally located longitudinally by a double set of 8-in.-wide horizontal members aligned respectively with the inside and outside of masonry sidewalls. The distance between the outer extremities of the mortises established the thickness of the walls at approximately 2 ft. 8 in.

To ensure the structural integrity of the roof, the pendant and kingpost assemblies almost certainly alternated. The cadence of these roof frames can be surmised from the horizontal timbers that connected them, indicating the interval as 8 ft. on center. The ridge pieces (*M* in the drawings this and facing pages), with vertical tenons, connected kingposts and pendants. The purlins (*L*), with horizontal tenons, connected the arched rafters and, spaced about 5 ft. apart, essentially divided each side of the arch into thirds.

The 16-ft. decoratively carved members were plates (*K*) running over the tiebeams and hammerbeams and in turn supporting the lower arched braces (*F*) and the lowest rank of ribs (*N*). Barnard mentioned these elements in noting “The carved oak beam support runs along the walls of the Ancient dining room and support[s] the archers of oak.” Pleasingly incised with a sawtooth design, the final horizontal element (*J*) formed a decorative band let into the upper sides of the alternating hammerbeams and ties (*7*).

Very little came to us of the upper roof system originally hidden above the vaulted ceiling. Of the two principal rafters that we did have, one terminated in a half-scarf joint with a peg hole. Among the odd unembellished timbers not previously assigned, we discovered several straight members (*H*) measuring 3x4 in. and about 8 ft. long. The lower joint in each case matched the scarf and the upper had an angled tenon that would align with the uppermost extremity of the kingposts and pendants had they not been cut short. Angled mortises in these same timbers implied diagonal struts (*I*), also tied to hidden upper kingposts and the posts that terminated in pendants.

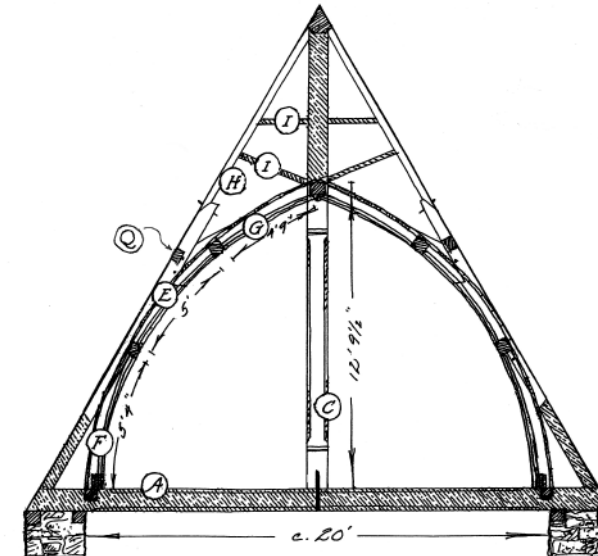
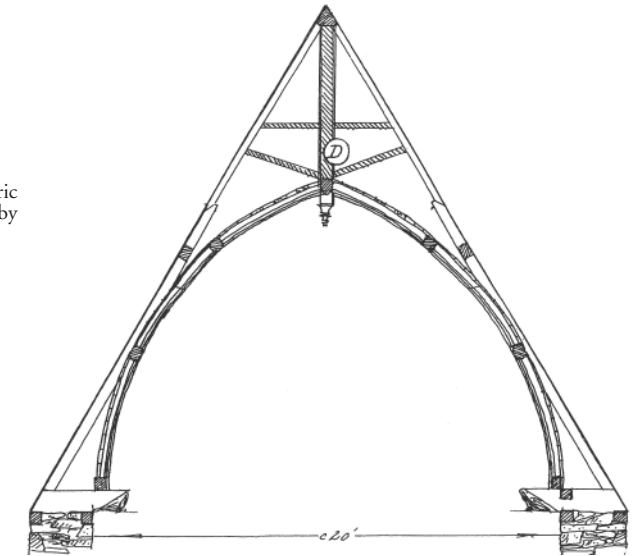
Drawings Elric Endersby

The hidden outer roof system probably demanded longitudinal components for which no evidence survives. There are 11½-in. long mortises near the original mid-point of the total rafter length in the roof plane (*Q*), which establish where purlins once connected the roof frames. A lower rank of hidden common rafters might have spanned the distance from the plates to these purlins, while a corresponding upper rank would have risen from the purlins to the ridge.

Assembly of the single principal rafter set with its curved braces allowed us to determine that the interior width of the building was just 20 ft.—remarkably narrow for such a long building, but not uncommon in timber frame truss construction of the period, as we learned by consulting the exceptional work by Patrick Hoffsummer et al., *Les Charpentes du XIe au XIXe siècle* (Monum, Paris 2002), which helped us substantially in proposing a likely configuration for the outer roof frame as shown in the sections above.

With the thickness of the outer walls determined at 2 ft. 8 in., the outside width of the structure was just over 25 ft., concurring with Barnard’s second measurement. The height of the stone walls could not be determined, but the height of the roof structure from the bottom of the tie beams to the peak of the outer roof would work out just short of 20 ft.

Barnard twice averred the length of the ceiling to be 160 ft. As this dimension coincided with a cadence of 8-ft. bays, we felt relatively confident in embracing this measure. At that length, the refectory would have required 10 pendant assemblies subdividing the bays formed by nine kingpost trusses. If this was the case, all the kingposts survive, none of the tie beams and just nine of 10 pendants and seven of 20 hammerbeams. For the entire vaulted ceiling, then, about two-thirds of the timbers survived extraction, shipping abroad and, just lately, a dormancy of some 60 years.
